General Information

Property Address *123 USA St*
City *Inspections* State *Ohio* Zip *11111*
Contact Name *Paul Inspector*
Phone *216-571-1074* Fax

Inspector Name *Paul Wancata*
Company Name *Inspections Unlimited*
Address *1535 Lourdes*
City *Parma* State *Ohio* Zip *44134*
Phone *216-571-1074* Fax
E-Mail *inspectionsunlimited@cox.net*
File Number *2011-1000*
Amount Received *\$285.00*

Others Present *Buyer's Agent and Buyer* Property Occupied *Occupied*
Estimated Age *20 Years Old* Entrance Faces *North*
Inspection Date *04/03/2011*
Start Time *10:00am* End Time *1:00pm*
Electric On *Yes*
Gas/Oil On *Yes*
Water On *Yes*
Temperature *75 Degrees*
Weather *Partly cloudy* Soil Conditions *Dry*
Space Below Grade *Basement*
Building Type *Single family* Garage *Attached*
Sewage Disposal *City* How Verified *Multiple Listing Service*
Water Source *City* How Verified *Multiple Listing Service*

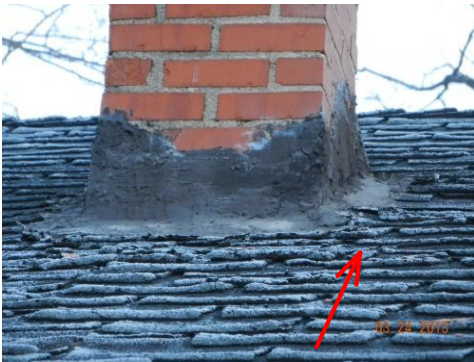
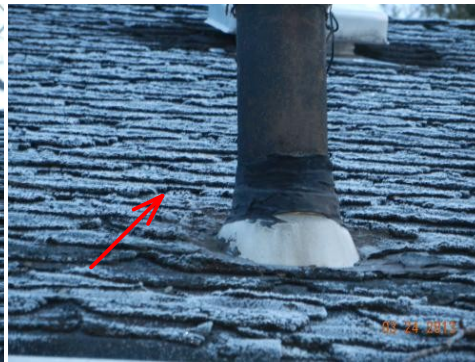
1. Type: *Gable*
2. Method of Inspection: *On roof*
3. Unable to Inspect: *25%*
4. Material: *Asphalt shingle*

Repair / Replace (Major)

Roof has deteriorating conditions and has reached the end of its useful life and should be budgeted for replacement.

1. Main Roof Surface Material: *Asphalt shingle* *Roof has deteriorating conditions and has reached the end of its useful life and should be budgeted for replacement.*

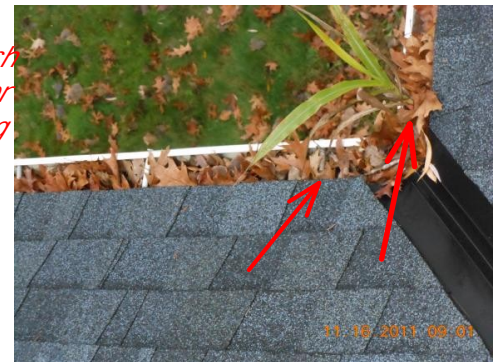
5. Flashing: *Aluminum*
6. Valleys: *Preformed metal*
7. Skylights: *Insulated glass*
8. Plumbing Vents: *PVC*
9. Gutters: *Aluminum*

Repair / Replace (Minor)

Gutters are dirty and filled with debris which can cause overflow of gutters and send water down foundation wall. Recommend cleaning by a roofing specialist.

1. Gutters: *Aluminum Gutters are dirty and filled with debris which can cause overflow of gutters and send water down foundation wall. Recommend cleaning by a roofing specialist.*
2. Main Chimney Chimney: *Brick Chimney requires tuck point repairs. Bricks material is cracked, popped, or broken surfaces. Recommend evaluation and repair by a mason contractor.*
3. Main Chimney Flue/Flue Cap: *Concrete Chimney cap cracked or deteriorated. Recommend evaluation and repair by a mason or chimney contractor.*

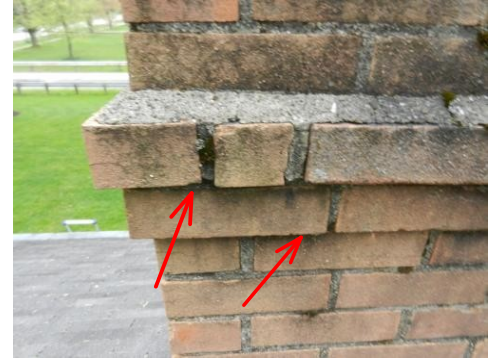
11. Chimney: *Brick*

Repair / Replace (Minor)

Chimney requires tuck point repairs. Bricks material is cracked, popped, or broken surfaces. Recommend evaluation and repair by a mason contractor.

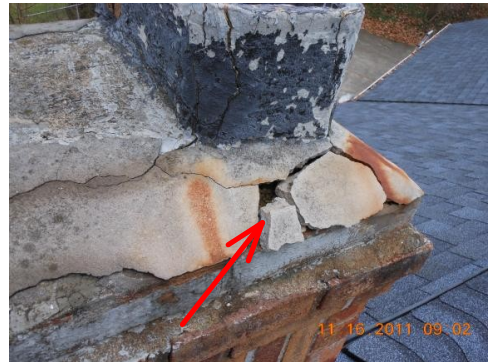
12. Flue/Flue Cap: *Concrete*

Repair / Replace (Minor)

Chimney cap cracked or deteriorated. Recommend evaluation and repair by a mason or chimney contractor.

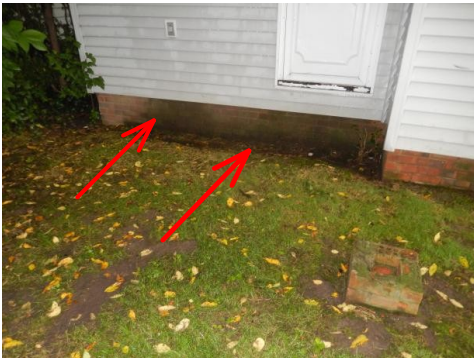
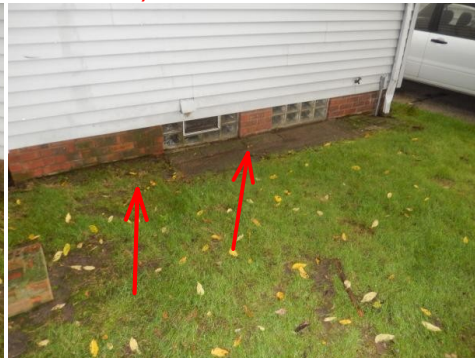
3. Grading: *Minor slope*

Repair / Replace (Minor)

Grading is sloped towards foundation which can cause moisture intrusion down foundation. Recommend evaluation and repair by a professional.

4. Grading: *Minor slope Grading is sloped towards foundation which can cause moisture intrusion down foundation. Recommend evaluation and repair by a professional.*
5. Vegetation: *Tall Trees Tree limbs over hang the roof and should be cut back*
6. Steps / Stoop Attached Exterior Component Support Components *Brick Tuck point repairs are needed. Recommend evaluation and repair by a mason contractor.*

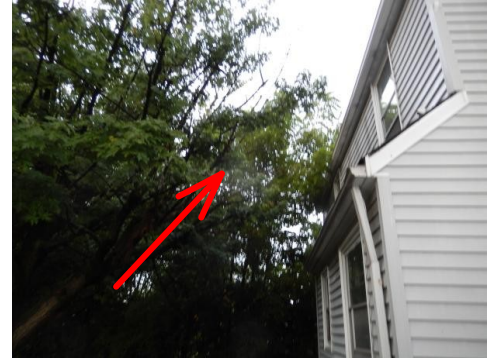
5. Vegetation: *Tall Trees*

Repair / Replace (Minor)

Tree limbs over hang the roof and should be cut back

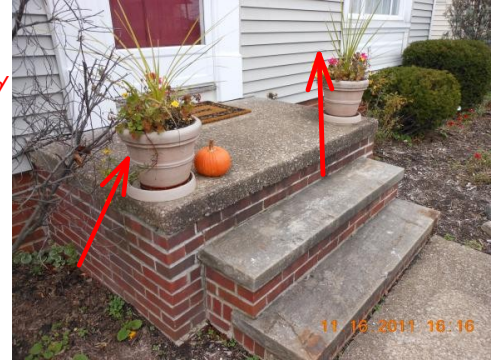
8. Railings Present? *No*

Safety Hazard

Handrails and balusters should be installed--this is a safety hazard and should be repaired immediately.

1. Steps / Stoop Attached Exterior Component Railings Present? *No Handrails and balusters should be installed--this is a safety hazard and should be repaired immediately.*

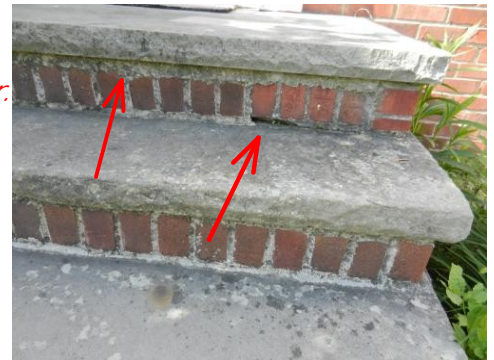
11. Support Components *Brick*

Repair / Replace (Minor)

Tuck point repairs are needed. Recommend evaluation and repair by a mason contractor.

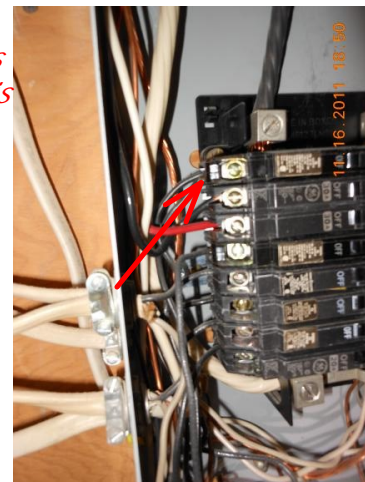
| 15. Breakers (110V) <i>Copper and Aluminum</i> | <i>Safety Hazard</i> |

Double taps are present at breakers. These circuits need to be moved to their own circuit breaker. This is a safety hazard and needs repair by a licensed electrician.

3. Basement Electric Panel Breakers (110V) *Copper and Aluminum Double taps are present at breakers. These circuits need to be moved to their own circuit breaker. This is a safety hazard and needs repair by a licensed electrician.*

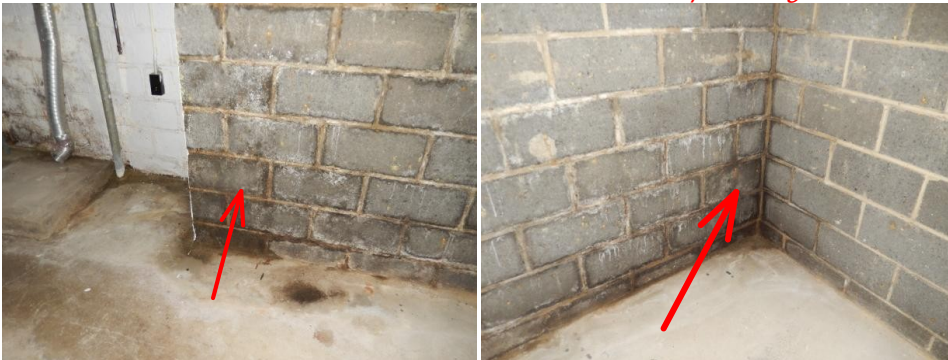
| 14. Moisture Location: <i>Block walls</i> | <i>Marginal</i> |

There is visible moisture staining on walls. Moderated to high levels of moisture indicated by moisture meter. Grading issues need to be corrected. Gutters and downspout issues need to be corrected. Resolving current issues will help to alleviate moisture issues. However, to completely alleviate moisture concerns, a waterproofing contractor would need to evaluate.

3. Main Basement Moisture Location: *Block walls There is visible moisture staining on walls. Moderated to high levels of moisture indicated by moisture meter. Grading issues need to be corrected. Gutters and downspout issues need to be corrected. Resolving current issues will help to alleviate moisture issues. However, to completely alleviate moisture concerns, a waterproofing contractor would need to evaluate.*
